Flood Control Project Maintenance
2018 Structure Summary Report
Overall Unit and Item Ratings

DWR Sacramento Maintenance Yard

Cache Creek Settling Basin Weir And Drainage Structure

Flood Control Project Maintenance
Unit Cover Sheet
2018 Structure Inspection Results

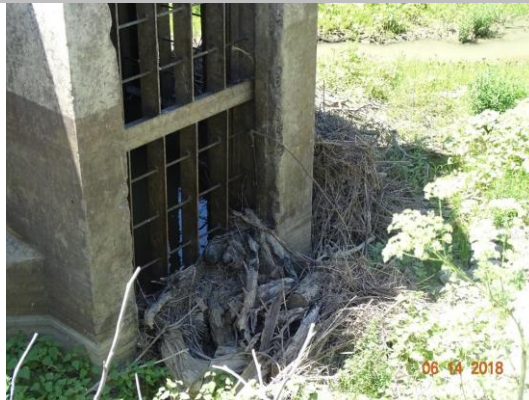
Photo 2 of 2 : ST_2018_NA0055_12_7_20180614_00015.jpg

View of debris blocking inlet. Summer 2018.

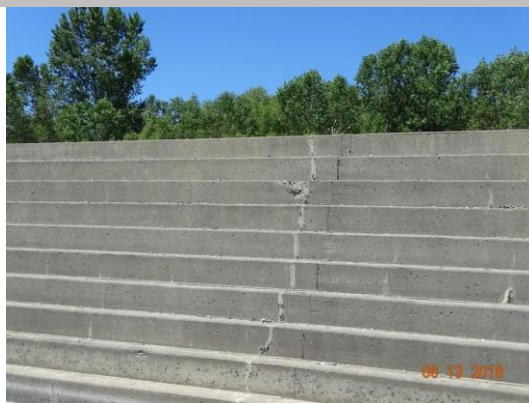
Photo 1 of 5 : ST_2018_NA0055_12_15_20180614_00024.jpg

LM Start	0.00	Rating **	A	Issue No.	15
LM End	0.00	Issue Type +	Ma	Location *	CR
Category	Structures & Concrete Lined Channels	GPS Latitude/Longitude			
		Start		End	
Item	Concrete Surfaces	38.682460 °		38.687350 °	
		-121.672930 °		-121.673740 °	
DWR ID	DWR_NA0055_12_t_2012_15				
Action/Comments					
Inspector Comments: Negligible spalling and cracking. Cracks should be sealed to prevent freeze/thaw damage.

Chipped piece of concrete on steps, near north end of the weir. Summer 2018.

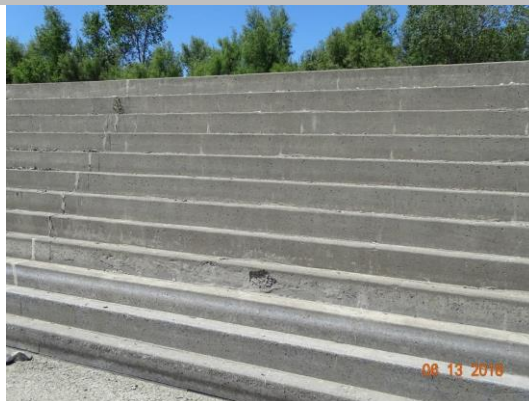
Photo 2 of 5 : ST_2018_NA0055_12_15_20180614_00025.jpg

Minor spalling on weir steps, near north end of the weir. Summer 2018.

LM Start	0.00	Rating **	A	Issue No.	15 (cont)
LM End	0.00	Issue Type +	Ma	Location *	CR
Category	Structures & Concrete Lined Channels	GPS Latitude/Longitude			
		Start		End	
Item	Concrete Surfaces	38.682460 °		38.687350 °	
		-121.672930 °		-121.673740 °	
DWR ID	DWR_NA0055_12_t_2012_15				
Action/Comments					
Inspector Comments: Negligible spalling and cracking. Cracks should be sealed to prevent freeze/thaw damage.

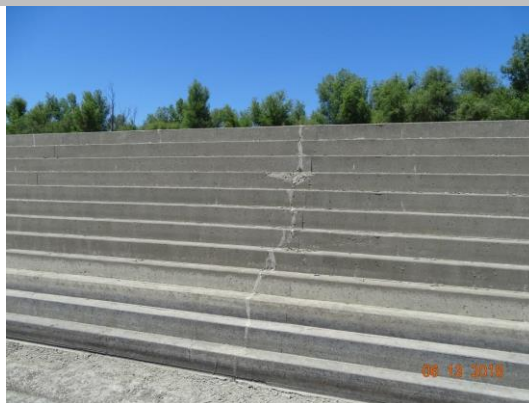
Photo 3 of 5 : ST_2018_NA0055_12_15_20180614_00026.jpg

Chipped piece of concrete on steps, approximately halfway down the weir. Summer 2018.

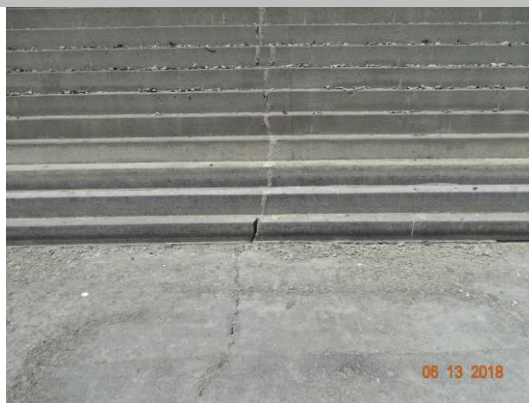
Photo 4 of 5 : ST_2018_NA0055_12_15_20180614_00027.jpg

Chipped piece of concrete on steps, near south end of the weir. Summer 2018.

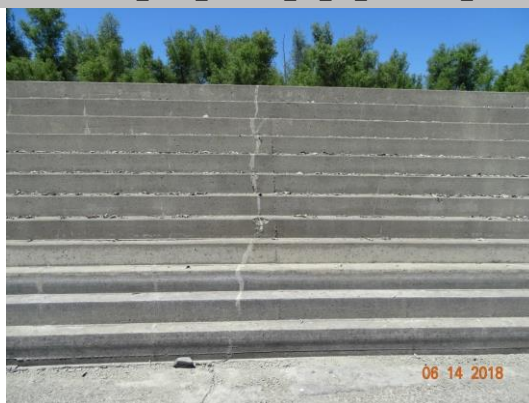
Photo 5 of 5 : ST_2018_NA0055_12_15_20180614_00028.jpg

Chipped piece of concrete on steps, near south end of the weir. Summer 2018.

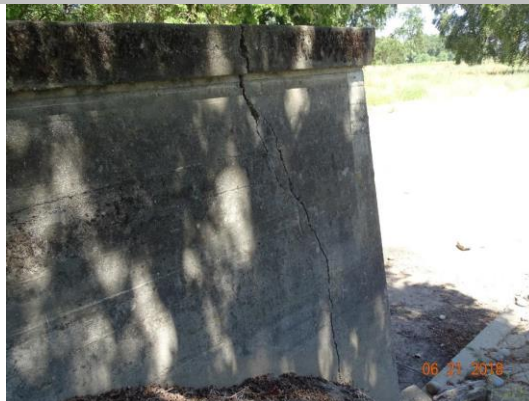
Photo 1 of 7 : ST_2018_NA0055_2_15_20180625_00015.jpg

View of crack at west weir abutment. Summer 2018.

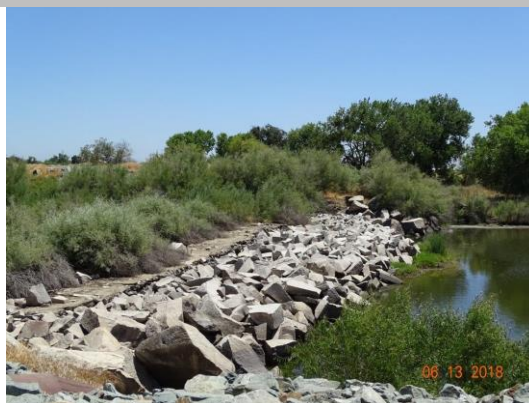
Photo 1 of 2 : ST_2018_NA0055_52_2_20180618_00010.jpg

View of the vegetation on the weir crest. Summer 2018

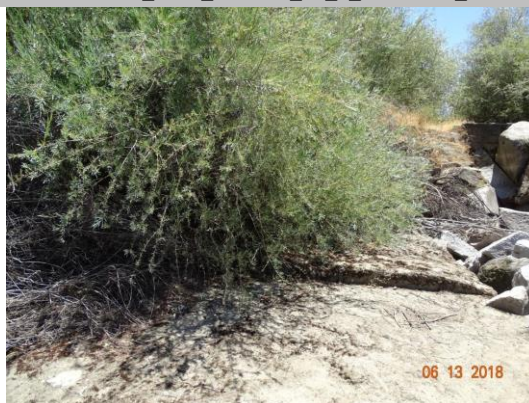
Photo 2 of 2 : ST_2018_NA0055_52_2_20180618_00009.jpg

View of the vegetation on the weir crest. Summer 2018

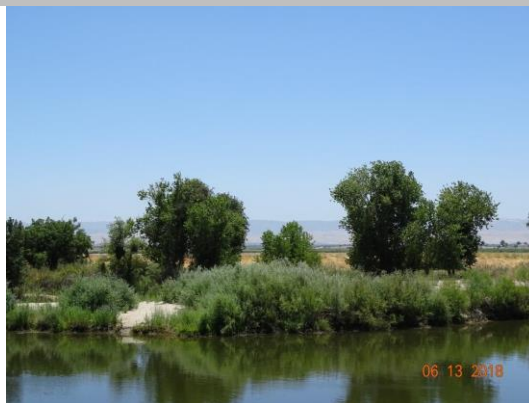
Photo 1 of 1 : ST_2018_NA0055_52_3_20180618_00011.jpg

View of sedimentation with brush on the left bank downstream of dam

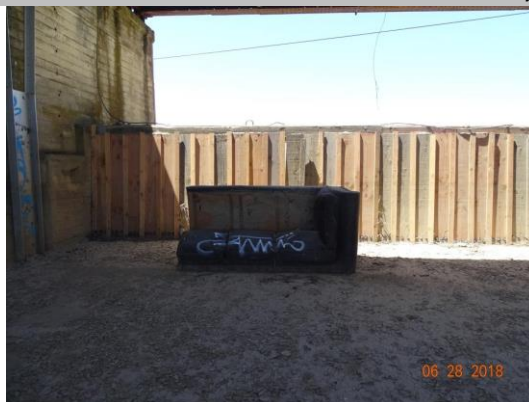
Photo 1 of 4 : ST_2018_NA0055_1_6_20180628_00011.jpg

View of couch in bay 9. Summer 2018.

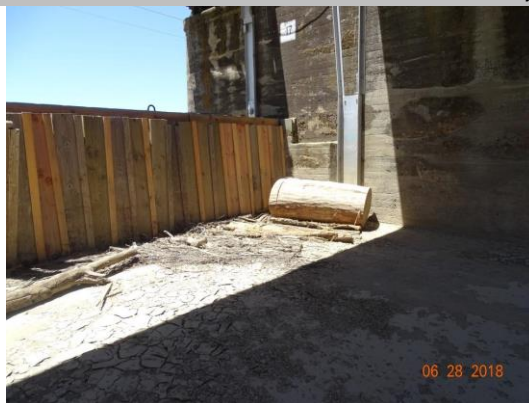
Photo 2 of 4 : ST_2018_NA0055_1_6_20180628_00012.jpg

View of cut tree trunk in bay 17. Summer 2018.

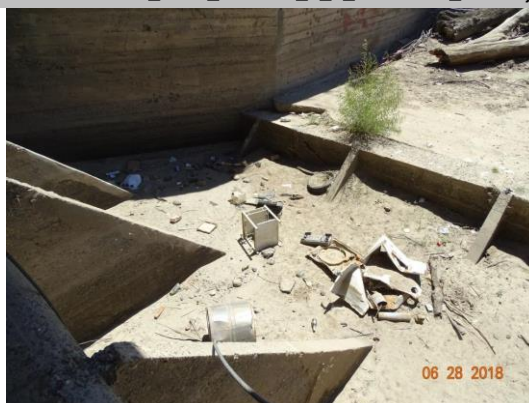
Photo 3 of 4 : ST_2018_NA0055_1_6_20180628_00013.jpg

Updated view of trash in bay 48. Summer 2018.

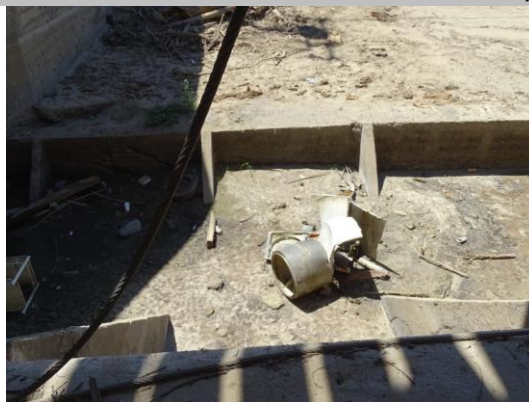
Photo 4 of 4 : ST_2018_NA0055_1_6_20180612_00001.jpg

View of trash in bay 48. Summer 2017.

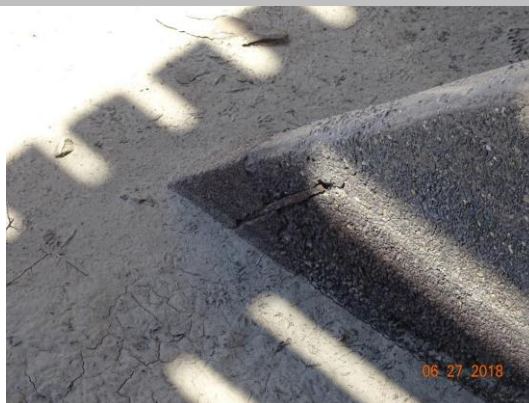
Photo 2 of 12 : ST_2018_NA0055_1_15_20180628_00015.jpg

View of exposed rebar on concrete counterfort within bay 1 stilling basin. Summer 2018.

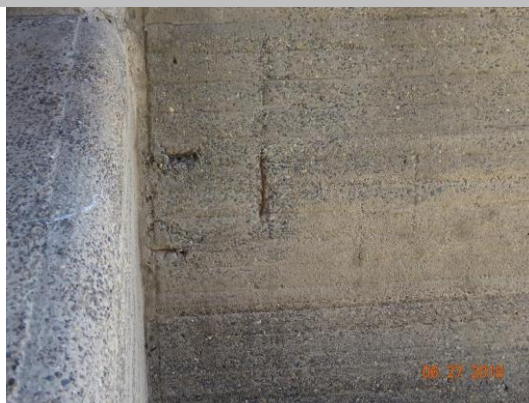
Photo 3 of 12 : ST_2018_NA0055_1_15_20180628_00016.jpg

View of exposed rebar on wall of bay 1. Summer 2018.

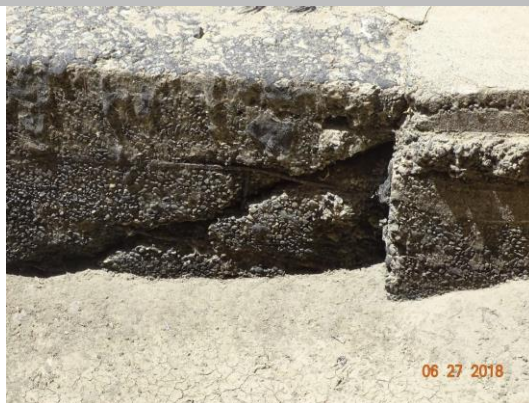
Photo 4 of 12 : ST_2018_NA0055_1_15_20180628_00017.jpg

View of exposed rebar within stilling basin of bay 1. Summer 2018.

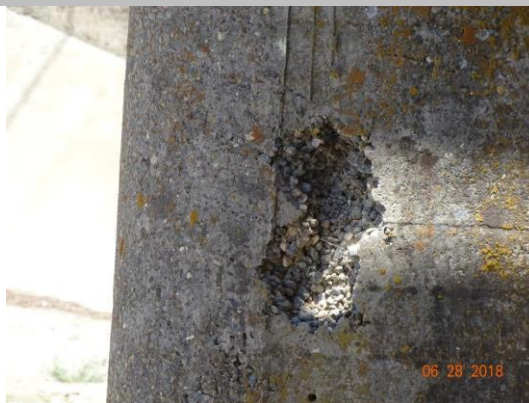
Photo 5 of 12 : ST_2018_NA0055_1_15_20180628_00019.jpg

View of spalling on bay 4 wall. Summer 2018.

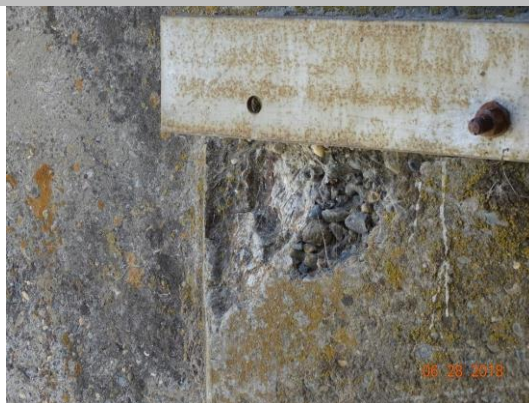
Photo 6 of 12 : ST_2018_NA0055_1_15_20180628_00020.jpg

View of spalling in bay 8. Summer 2018.

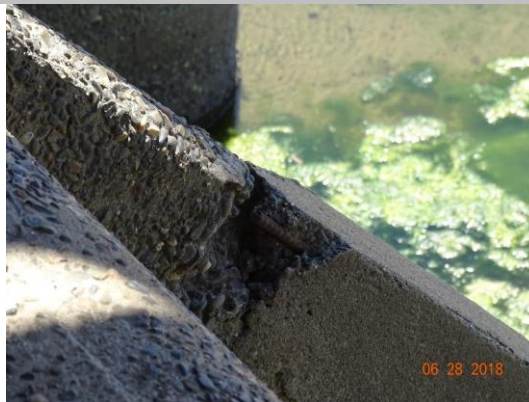
Photo 7 of 12 : ST_2018_NA0055_1_15_20180628_00021.jpg

View of exposed rebar on counterfort in bay 21. Summer 2018.

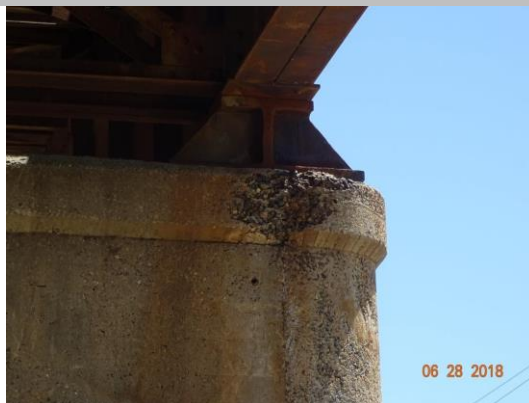
Photo 8 of 12 : ST_2018_NA0055_1_15_20180628_00025.jpg

View of spalling at the top of bay 38 wall. Summer 2018.

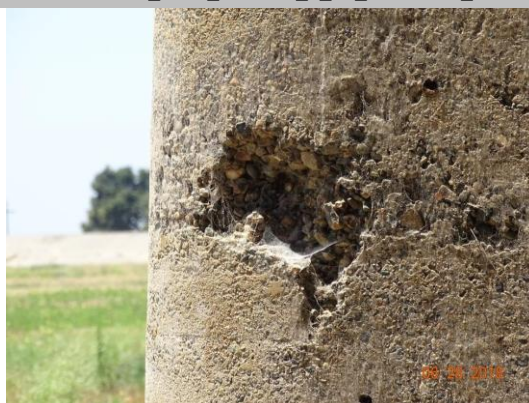
Photo 9 of 12 : ST_2018_NA0055_1_15_20180628_00023.jpg

View of spalling on bay 43 wall. Summer 2018.

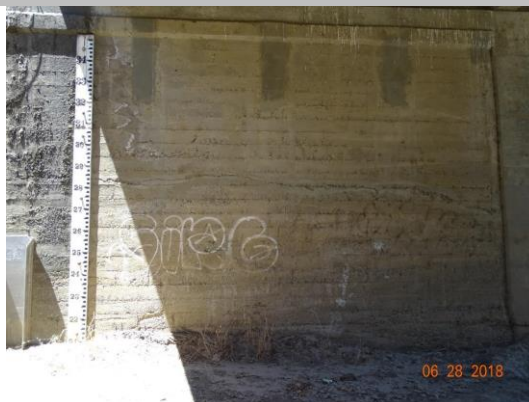
Photo 10 of 12 : ST_2018_NA0055_1_15_20180628_00024.jpg

View of large crack on bay 48 wall. Summer 2018.

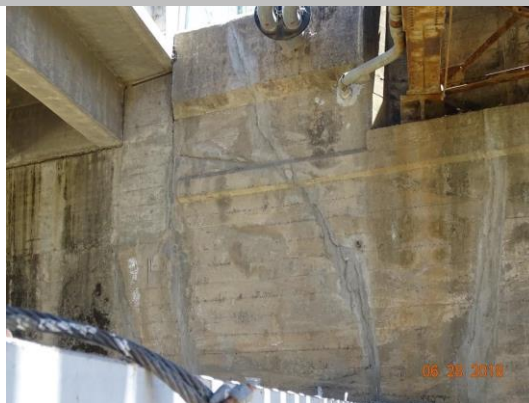
Photo 11 of 12 : ST_2018_NA0055_1_15_20180628_00026.jpg

View of crack on bay 1 wall. It appears that it was previously patched, but it is beginning to open up again. Summer 2018.

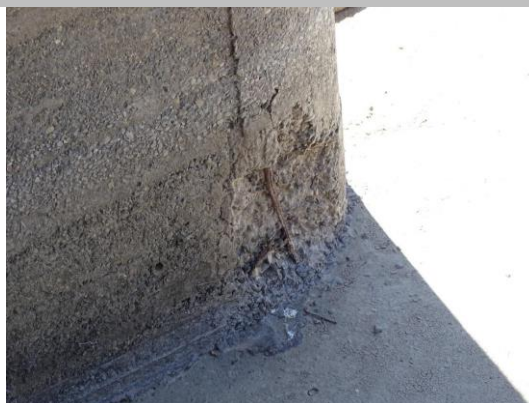
Photo 12 of 12 : ST_2018_NA0055_1_15_20180612_00005.jpg

Exposed rebar at the base of the structure in bay 6. Summer 2017.
